# Rim Fire

BASCWA Annual Technology Transfer Workshop  
November 13, 2013

Adam Mazurkiewicz  
Water Operations Analyst/Hydrologist  
Hetch Hetchy Water and Power  
Water Enterprise

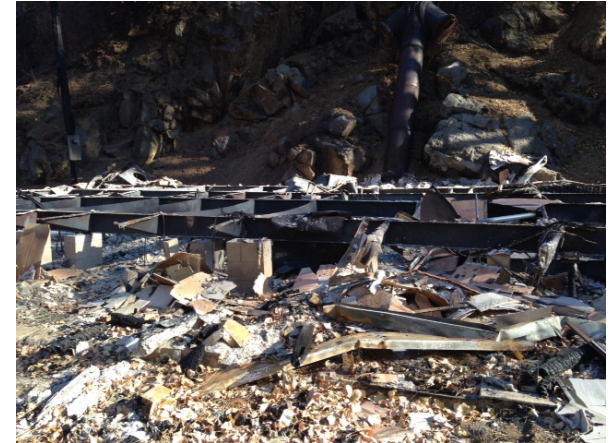
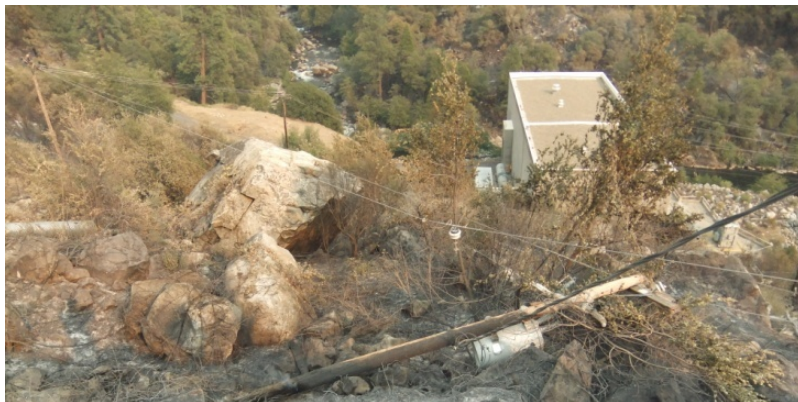
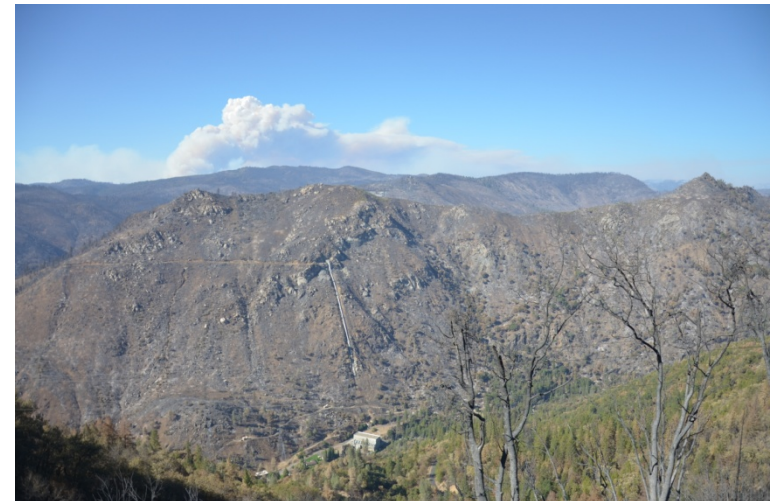
# SFPUC Affected Assets

- **No damage to water delivery system**
- Distribution lines damaged
  - Cherry Ridge Line, Mather Line, Intake Camp, OSH
- Holm Powerhouse – roof fire
- Loss of communications
- Lost multiple non-critical structures
  - Cottage @ Intake, storage sheds, Miguel Meadows Cabin, LCA Gate House facility
- Damage to road system

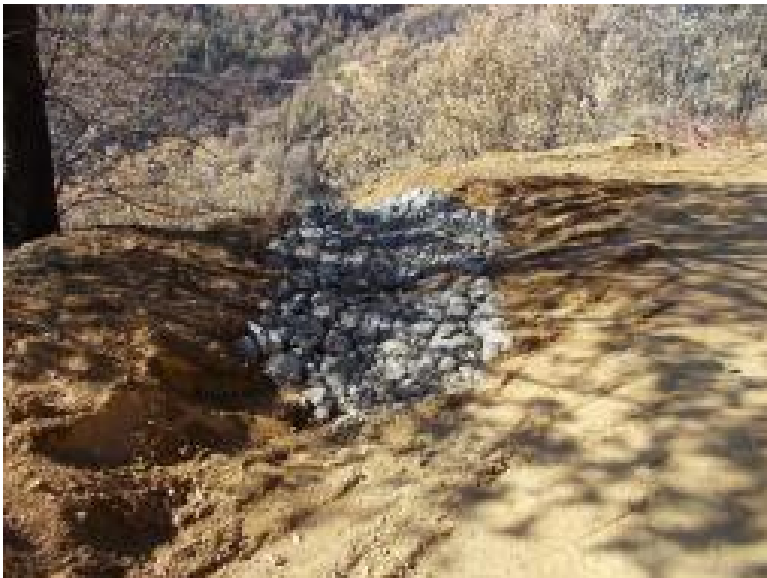
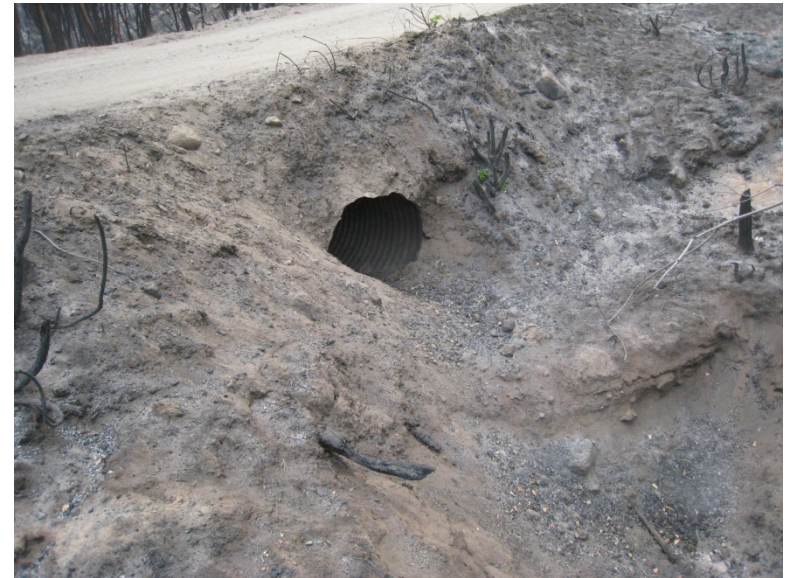
# Recovery from the Fire – Preparation for Winter

- Forest closure
- Hazard tree clearing
- Road rehabilitation
- Recreation closures
- USFS closing of roads
- Slope stabilization

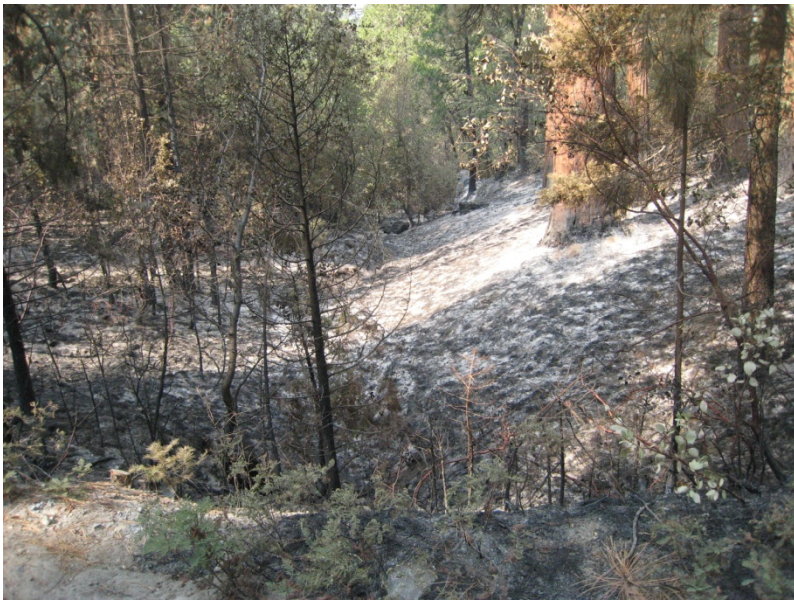
← *Low: surface material is not completely burned, structural stability of soil is unchanged*

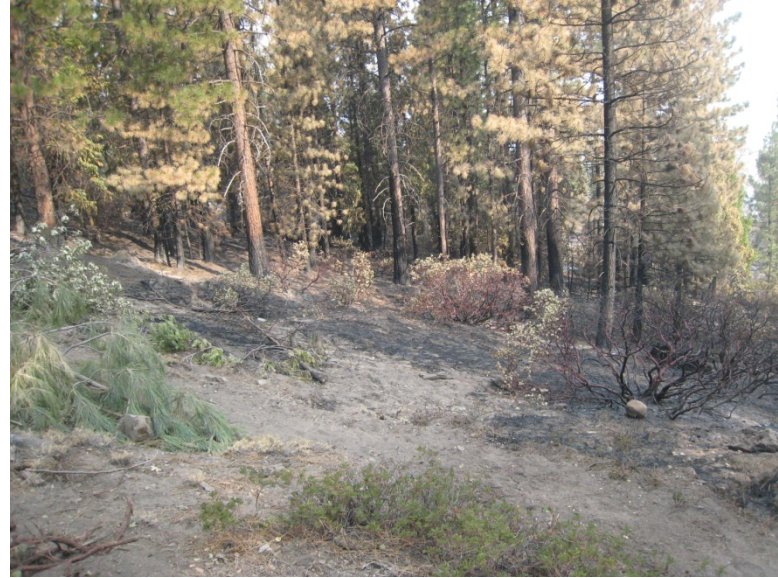
*Moderate: ground cover is consumed, ash may be blackened with patches of gray* →

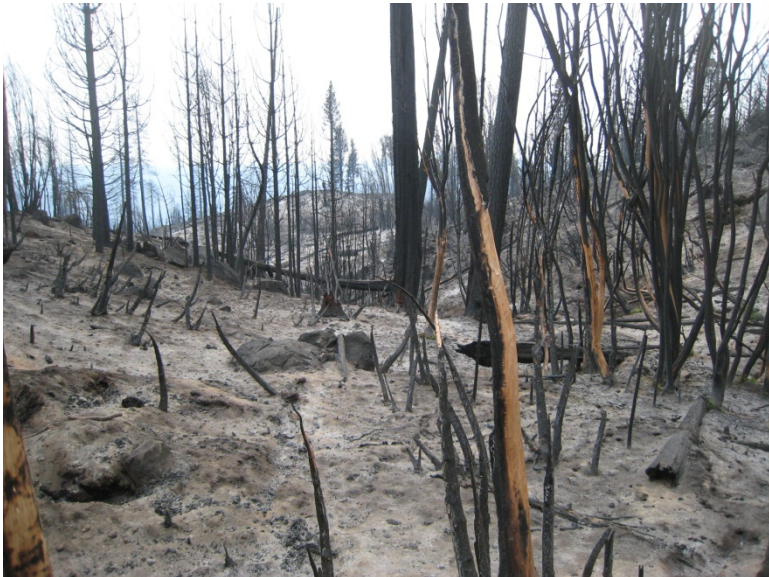
← *High: all of the ground cover is consumed, bare soil and ash, loss of soil structure*

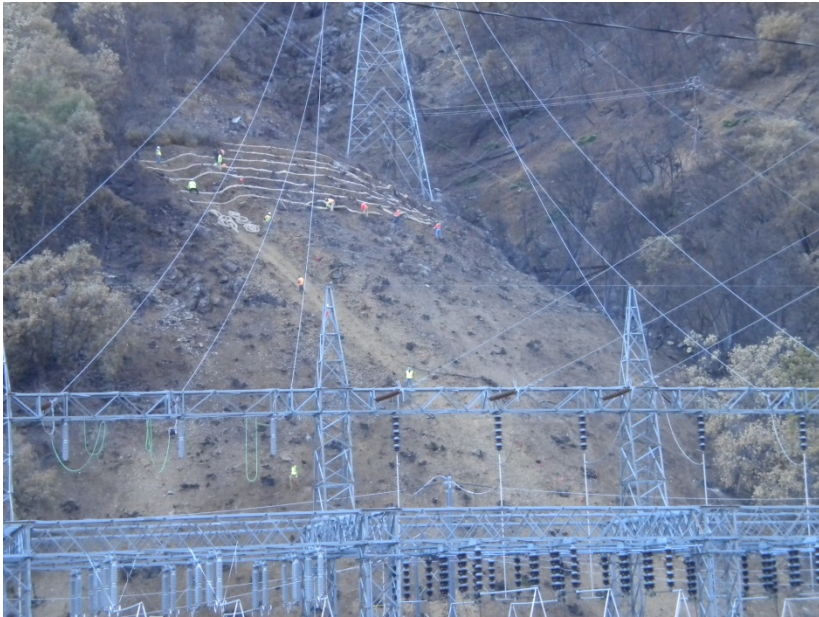
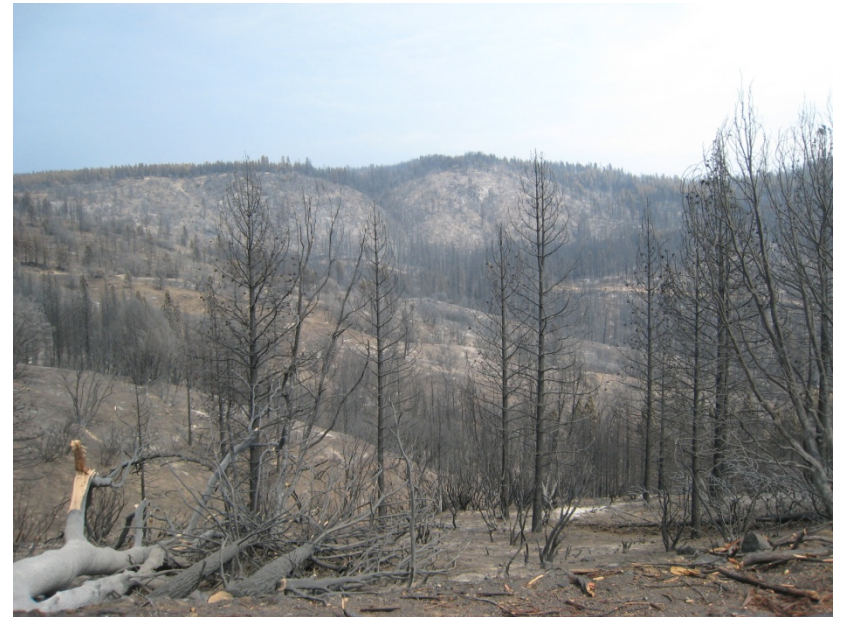
# BAER Recommendations relating to SFPUC

- BAER makes recommendations for USFS & NPS facilities and lands
  - However, there is overlap to SFPUC
- Mastication and helimulching in Granite Creek basin
- Culvert clearing along the SFPUC Right of Way (ROW)
- Sandbagging stream channel adjacent to facilities in the HH compound to contain high flows
- Hazard tree removal, slope stabilization

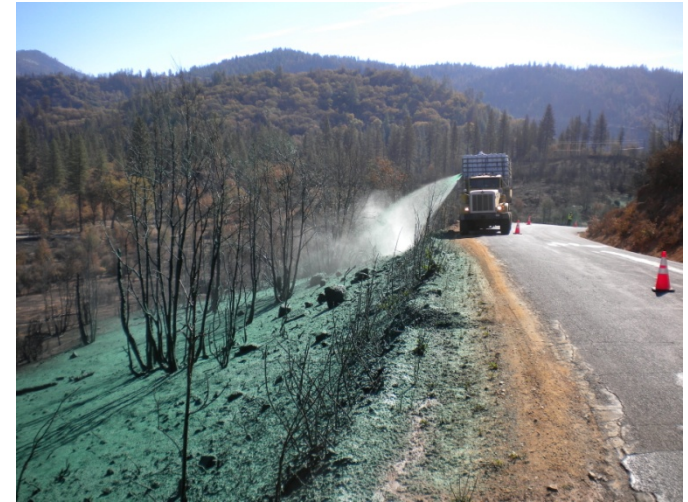
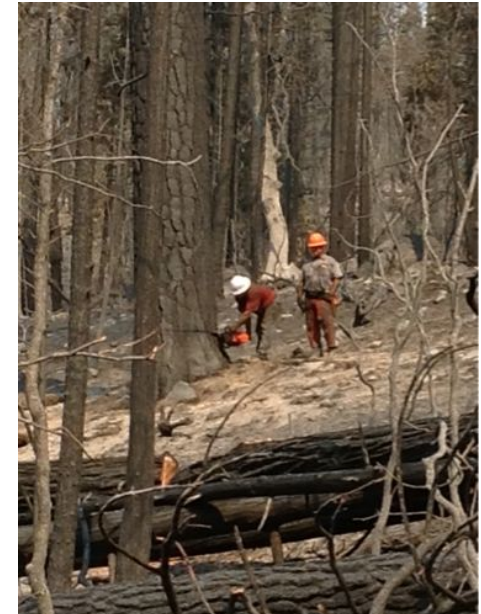
# SFPUC Post-Fire Actions

- Initial Response
  - Cleared hazard trees along roads and power lines
- Roads
  - Replaced culverts, pulled ditches, removed floatables, cleared culverts, hydromulching
- Logging operations
  - Along the ROW to remove trees
- Powerlines
  - Re-established power to Camp Mather – working on lines to Hetch Hetchy and Cherry

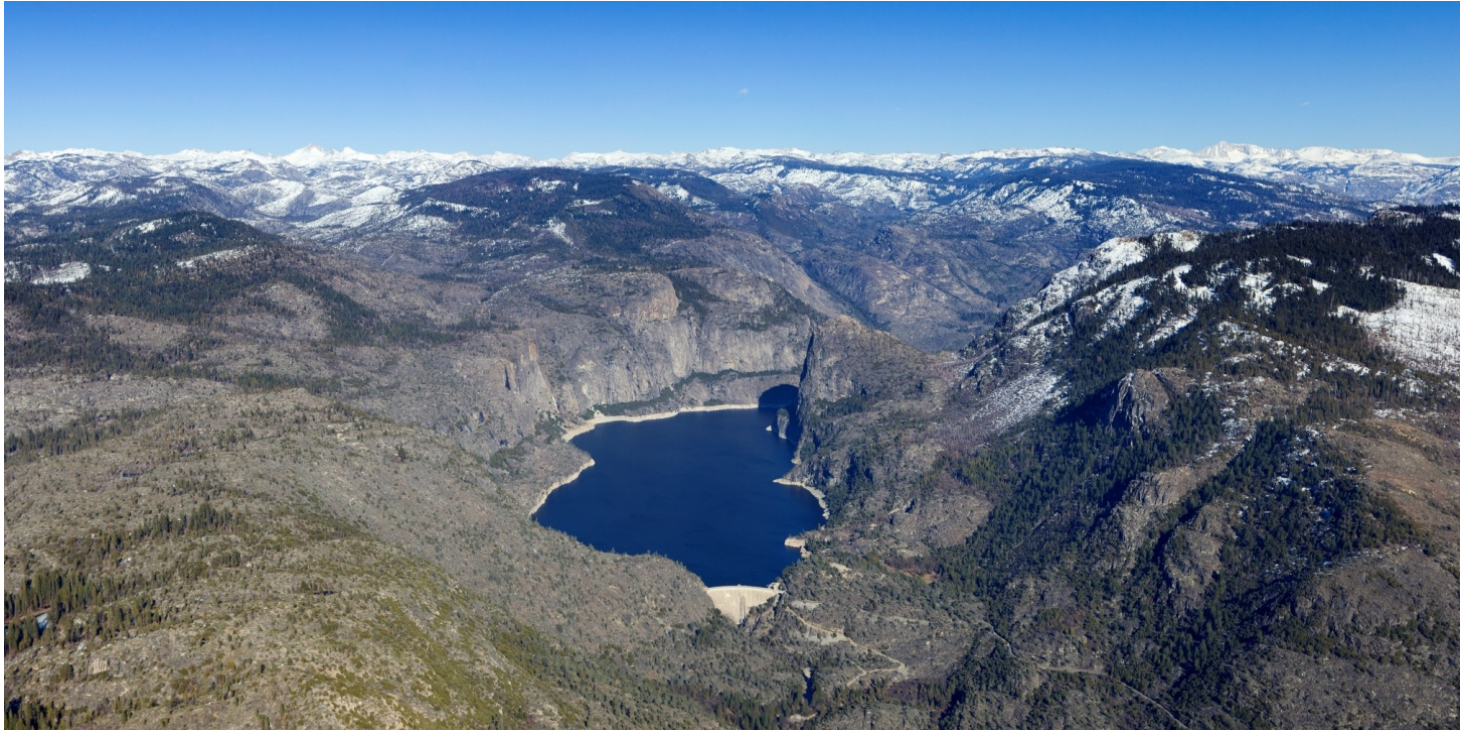
# Hetch Hetchy Watershed

- Granite dominated basin
- Few sediment sources
- Generally low forest densities
- Discontinuous forest stands
- Nutrient limited
- Limited fuels near reservoir
- Active fire history

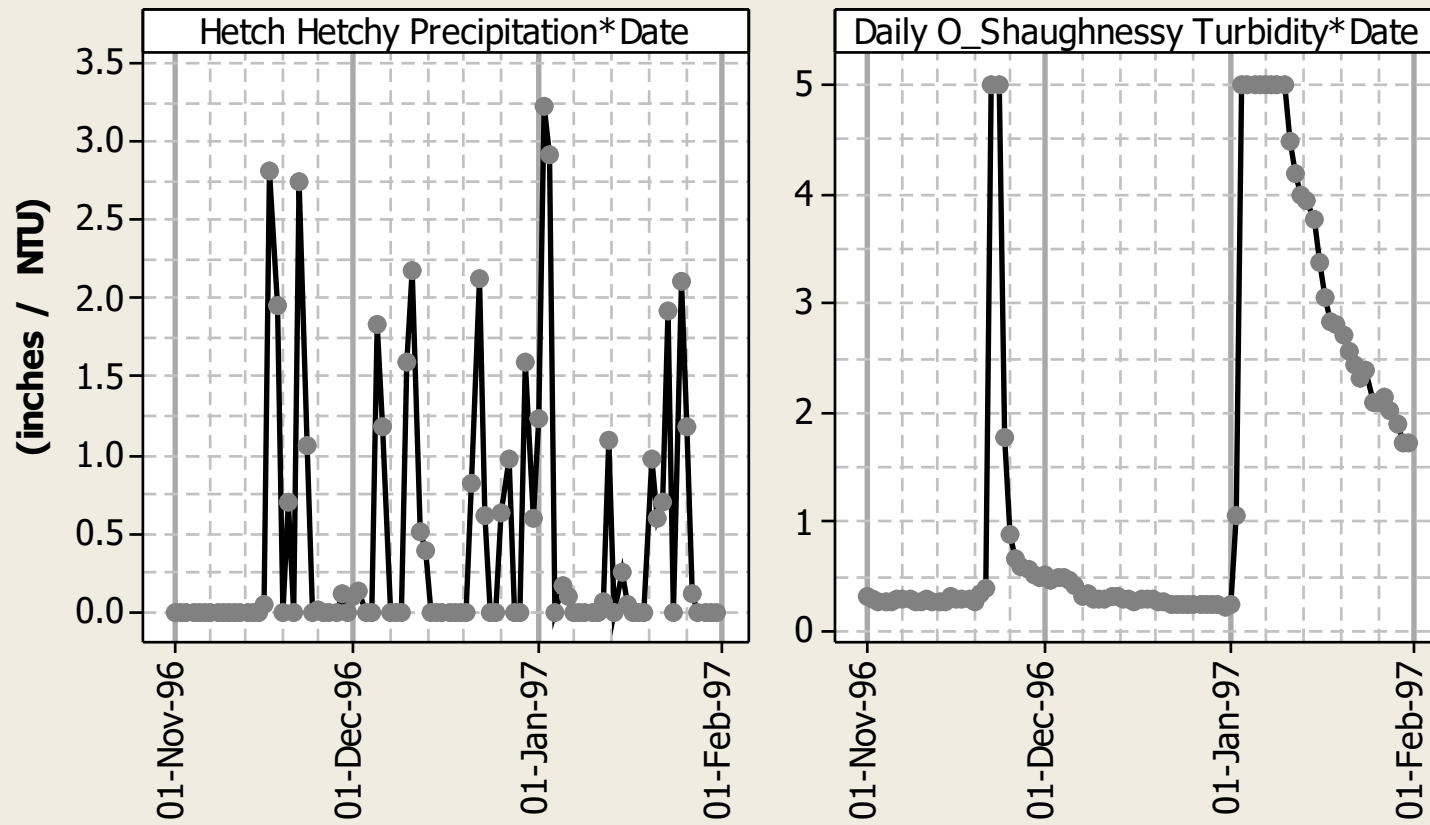
**Precipitation at Hetch Hetchy and O'Shaughnessy Turbidity**  
November 1996 through January 1997

- Turbidity is typically 0.15 to 0.5 NTU
- Elevated turbidity occurs during periods of high inflows
  - i.e. snowmelt runoff & major storms
- Two historical events impaired Hetch Hetchy water quality
- Prior post-fire data show no detectable change in nutrient levels (N, TOC, P) following a fire
- Historical data shows that turbidity is driven by runoff magnitude with no direct correlation to burned area

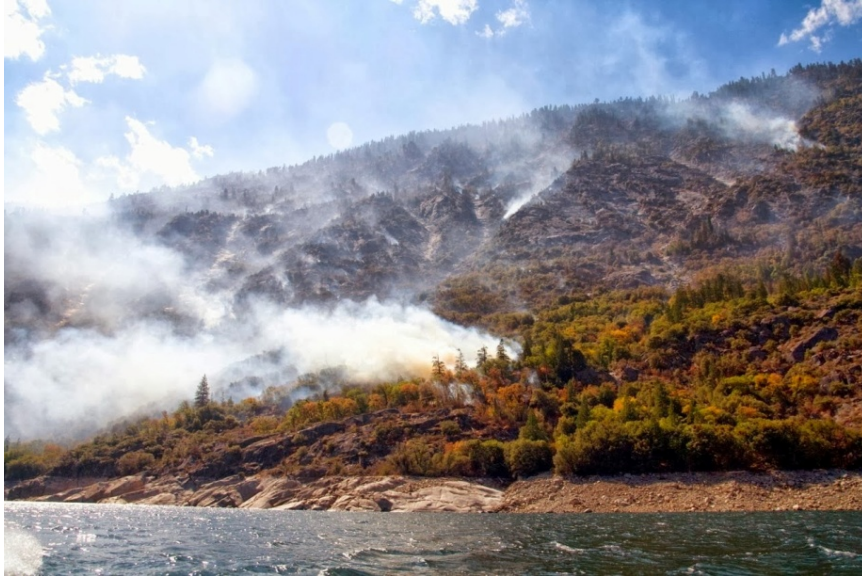
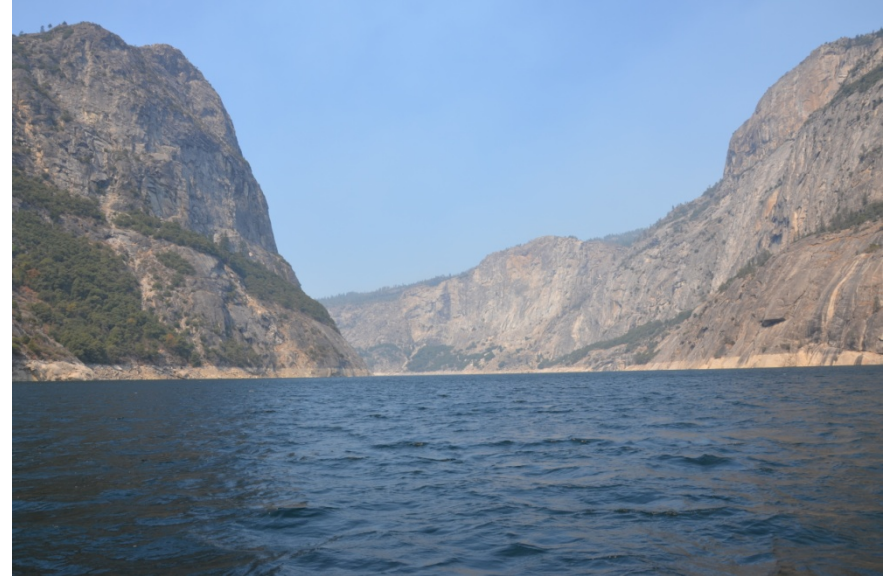
# Rim Fire: Field Assessments

- During and post-fire on the ground observations
- Limnology and chemistry sampling in Hetch Hetchy
- Field Hydrology tests: infiltration & hydrophobicity

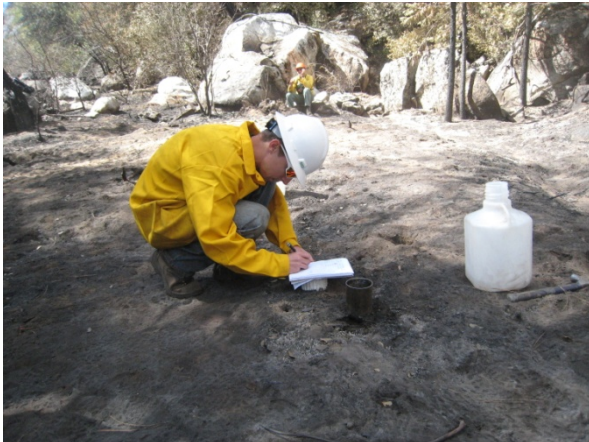
# Hydrophobicity and Infiltration Tests

- Tests show that infiltration rates are typical for soil texture
  - 3-8 inches per hour
  - Some decrease from measured rates at unburned areas
  - Well below precipitation rates
- Tests show soil rates extremely hydrophobic
  - Water drops sit on soil surface >2 minutes
  - Surface of mineral soil, rather than overlaying organic layer
  - Soils are naturally hydrophobic due to soil /vegetation properties
  - Infiltration tests show hydrophobicity effects lessen under wetted soils

Location	Burn Intensity	Infiltration Rate	Hydrophobicity
Hetch Hetchy South Shore	Light	7.6 in/hr	Extreme
Hetch Hetchy North Shore (1)	High	7.7 in/hr	Extreme
Hetch Hetchy North Shore (2)	High	3.0 in/hr	Extreme
Hetch Hetchy No Burn (1)	None	19.3 in/hr	High/Extreme
Hetch Hetchy No Burn (2)	None	12.1 in/hr	High/Extreme

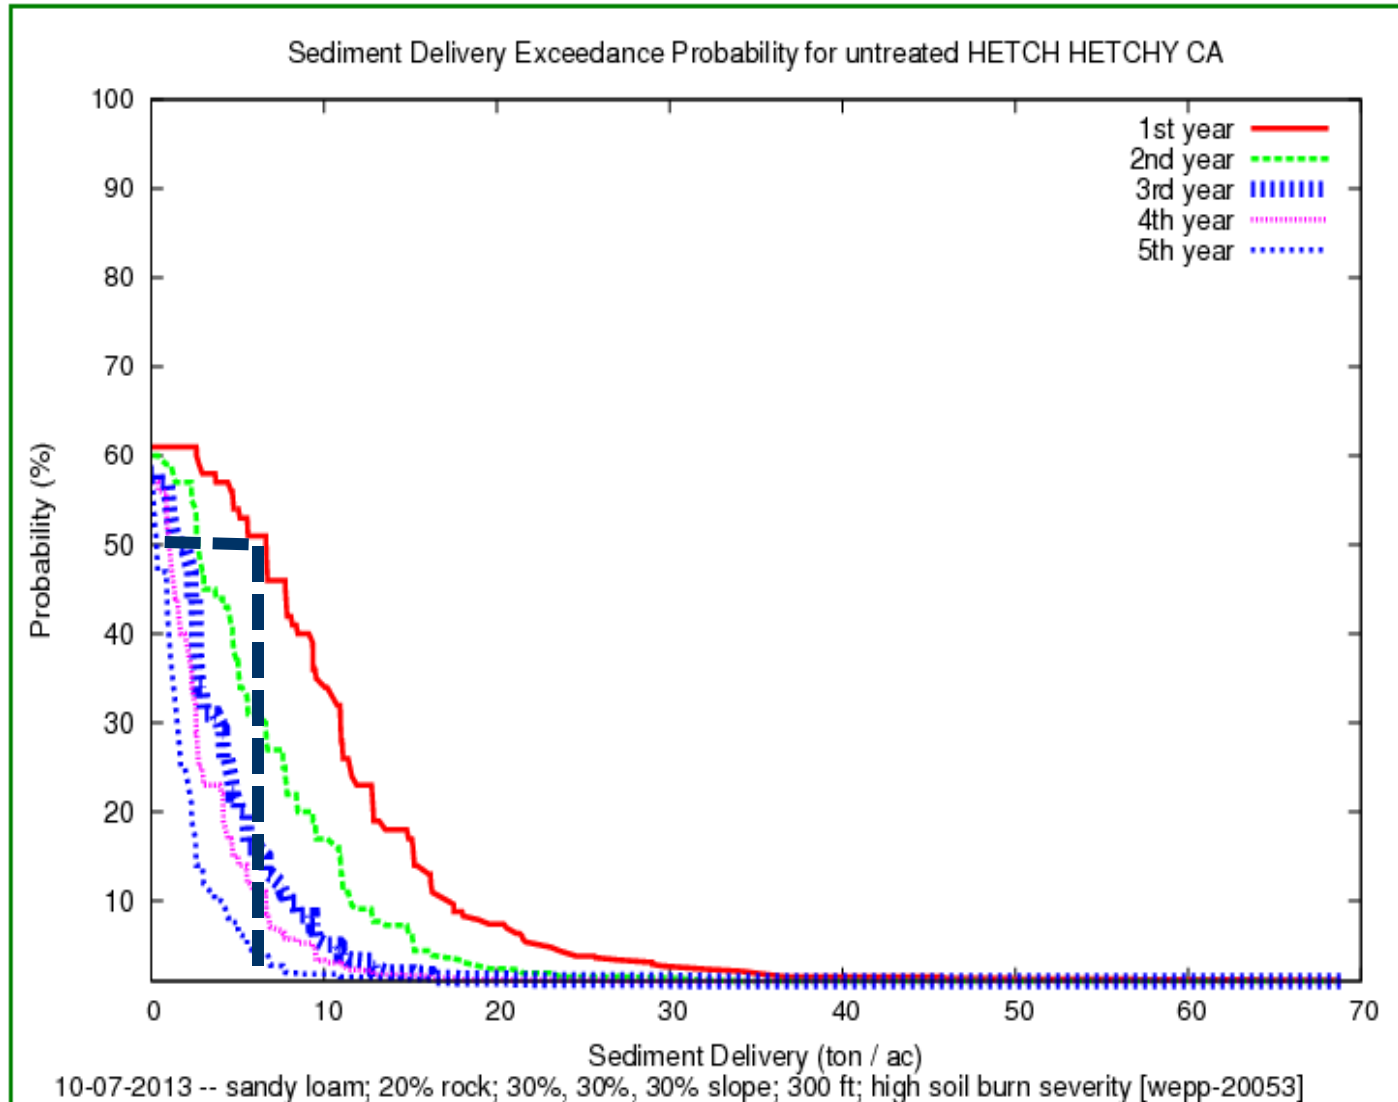
# ERMiT: Sediment Exceedance Probability

Potential Sediment Increase @ affected locations  
2-3 times for low burn severity sites  
3-4 times for moderate severity sites
